Subject: Site Summary Report for the Storm Sewer System near IR19, IR21/Buildings

386/388/390 Area, PCB Site Building 678 AL#04 and PCB Site Building 830 UL#01 in Investigation Area C2, Lennar Mare Island, Vallejo, California

Site Summary Report for the Storm Sewer System near IR19, IR21/Buildings 386/388/390 Area, PCB Site Building 678 AL#04, and PCB Site Building 830 UL#01 in Investigation Area C2, Lennar Mare Island, Vallejo, California

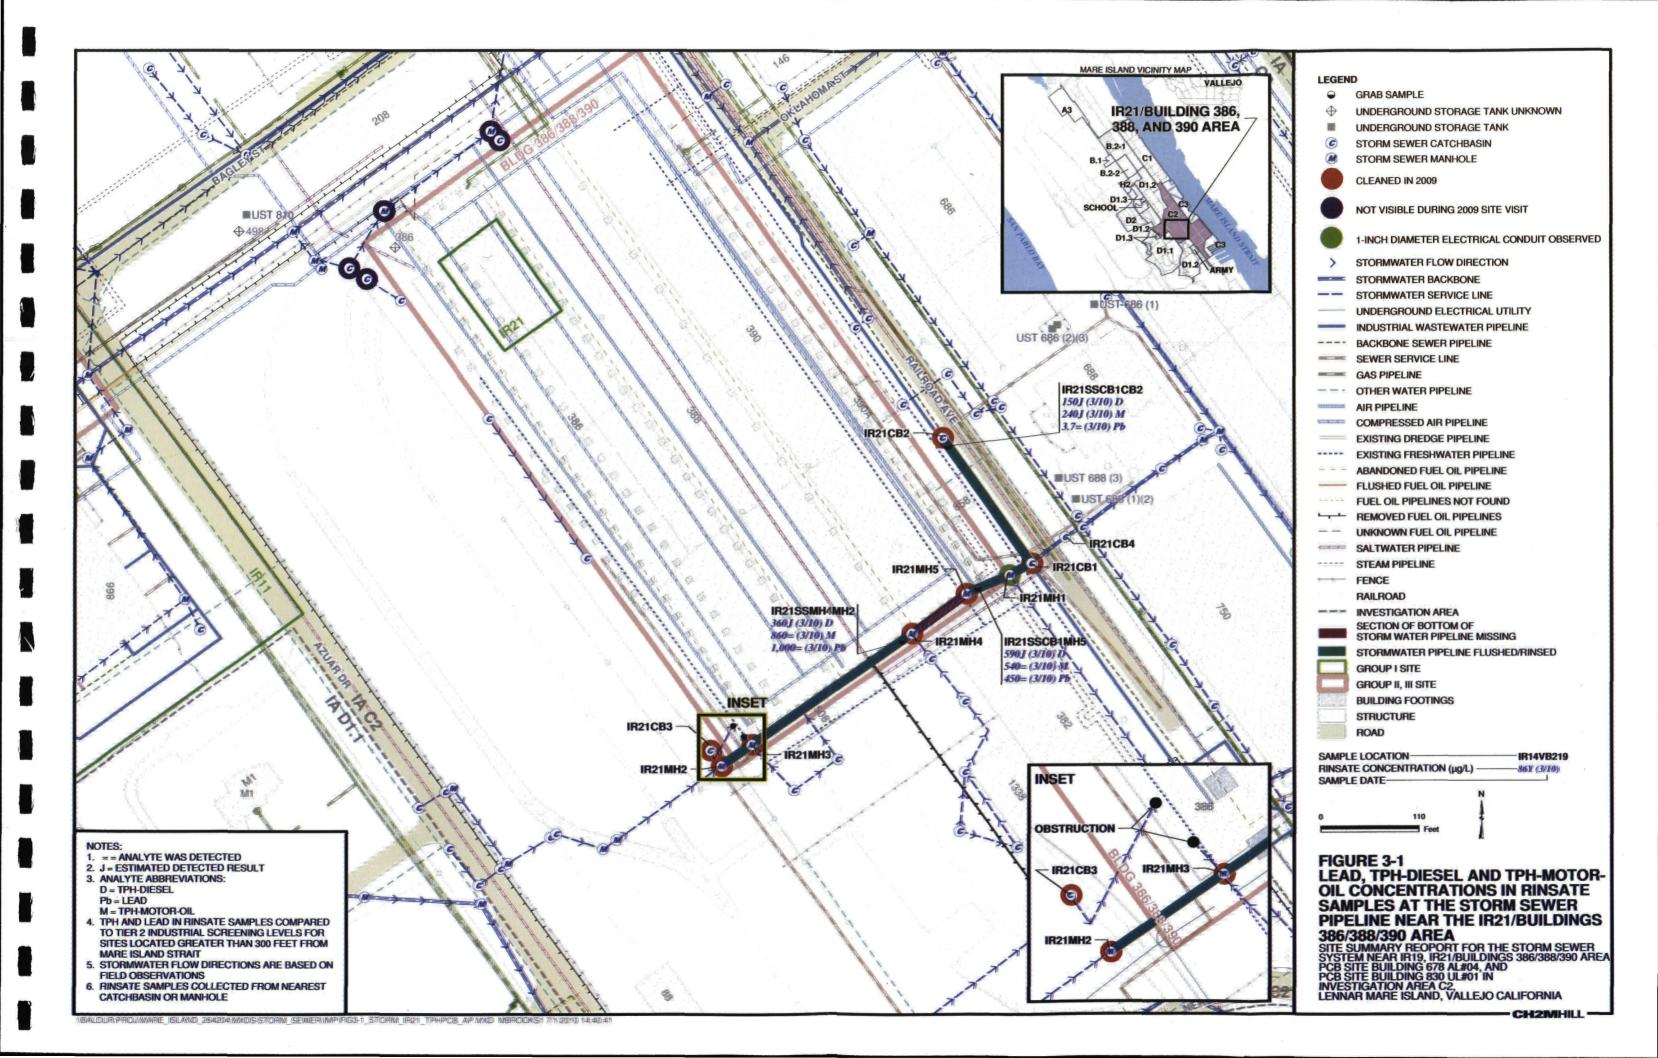
- Several CBs/MHs shown on storm sewer Navy Quad maps for the site could not be located. The storm sewer Navy Quad maps were used to create the storm sewer configuration at the IR21/Buildings 386/388/390 Area shown in Figures 1-3 and 3-1 through 3-3. The CBs and MHs that appear on storm sewer Navy Quad maps that were not observed at the site are shown in these figures. A description of stormwater drainage through the storm sewer system near the IR21/Buildings 386/388/390 Area, based on current understanding of site conditions, is discussed in Section 3.3.3.

- A pipeline connection between IR21CB3 and IR21MH2, shown on storm sewer Navy Quad maps for the site, was found to be disconnected. A pipeline exiting IR21CB3 was observed; however, an inlet pipeline to IR21MH2 was not observed. A pipeline tracer video inspection was performed by Subtronic Corporation on March 26, 2010 to evaluate where the outlet pipeline in IR21CB3 leads, as described in Section 3.3.6. Additionally, a pipeline connection between IR21CB3 and the CB immediately upgradient of IR21CB3 on the west side of Building 386 (Figure 3-1) was not observed. The storm sewer Navy Quad maps for the site show a connection between these two CBs; however, an inlet pipeline in IR21CB3 from the upgradient direction was not observed during the site reconnaissance. Figure 3-1 show the observed configuration of these pipelines based on field observations.

- Lateral pipeline connections were observed in IR21MH3, IR21MH4, and IR21MH5. These lateral pipelines were also noted during the CCTV video inspections (discussed in Section 3.3.1 and 3.3.7). Figure 3-1 show the observed configuration of these pipelines based on field observations.

- IR21CB2 has one outlet pipeline that connects to IR21CB1. There is no inlet pipeline in IR21CB2, as shown in Figure 3-1.
- Two 1-inch-diameter electrical conduit pipes were found passing through the top of IR21MH1, as shown in Figure 3-1. Because they were passing through the top of the MH, cleaning activities could proceed at the bottom of IR21MH1 without removing the electrical conduit pipes.

This section discusses stormwater drainage through the storm sewer system near the IR21/Buildings 386/388/390 Area and is based on current understanding of site conditions. Stormwater that does not infiltrate into the subsurface enters one of the CBs or MHs surrounding the building. The stormwater is then carried downgradient through the storm sewer pipelines located along the north, south, and east sides of the combined Buildings 386/388/390, under Railroad Avenue in the direction of Mare Island Strait, as depicted in Figure 3-1.

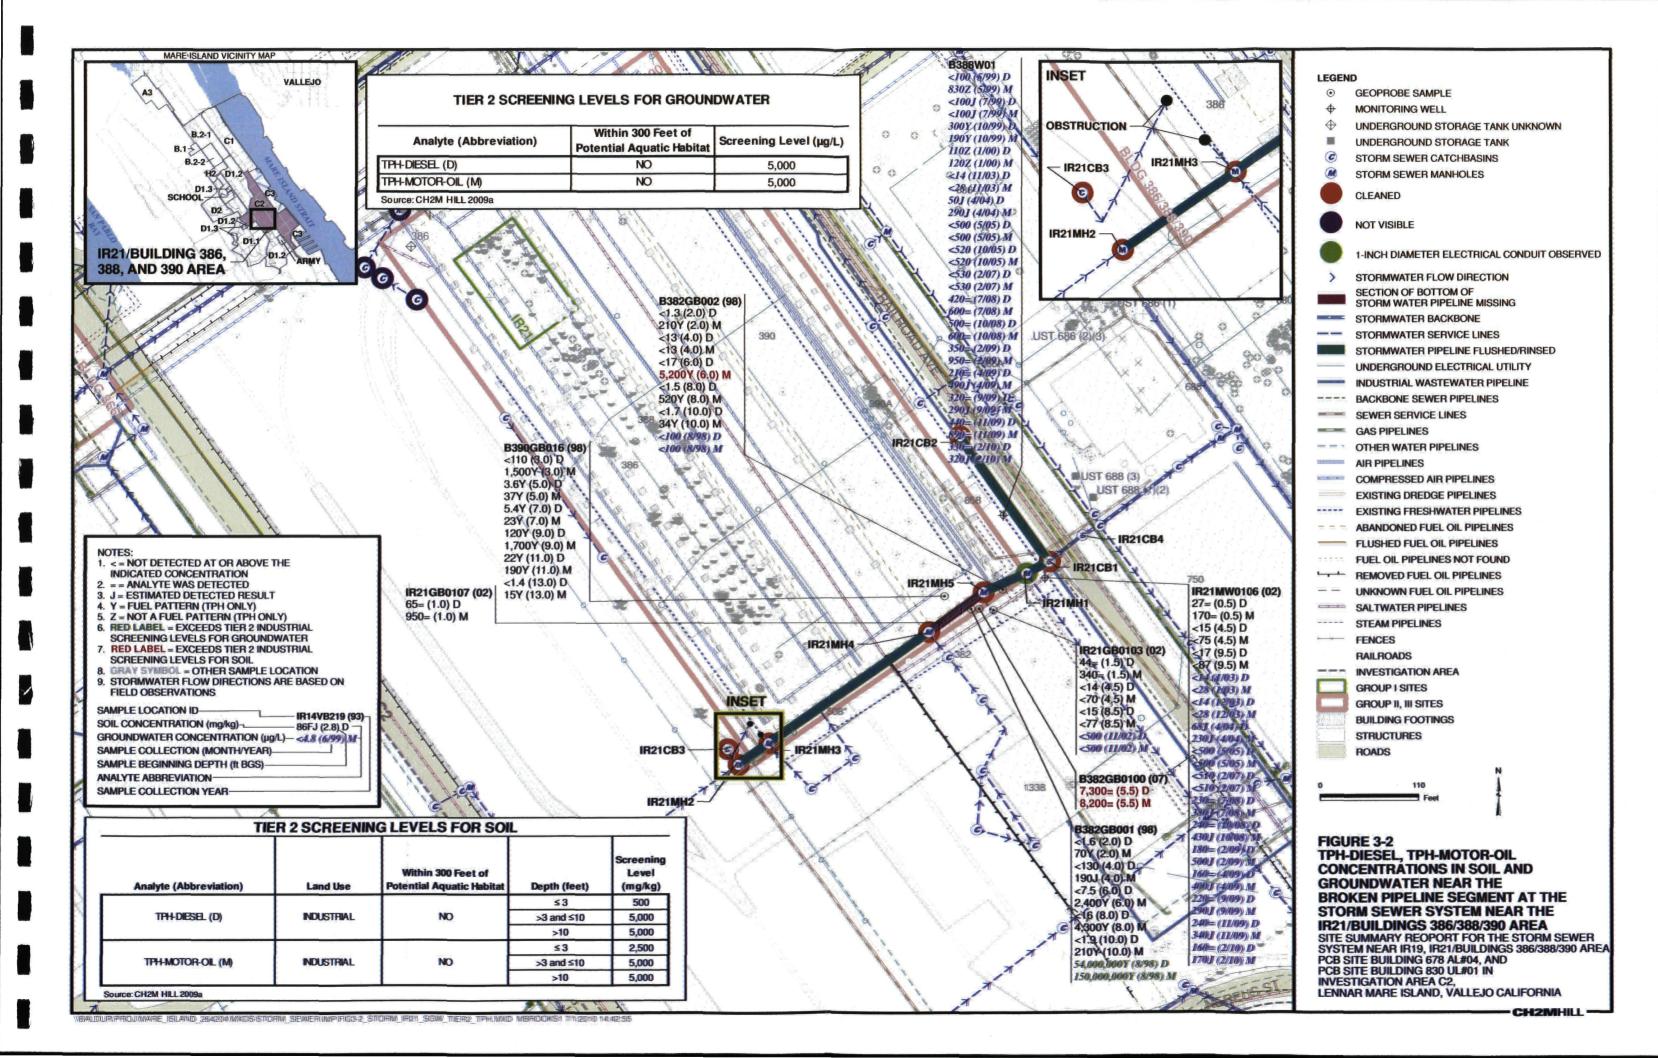
As shown in Figure 3-2, one soil sample (B382GB0100 at 5.5 feet bgs) located approximately 5 to 10 feet from the broken pipeline segment contains concentrations of TPH-diesel (7,300 mg/kg) and TPH-motor oil (8,200 mg/kg) that exceed the Tier 2 screening levels. The remaining soil samples collected from locations on or adjacent to the broken pipeline segment are below Tier 2 screening levels. Based on the boring log for soil sample B382GB0100 (CH2M HILL 2009g), three borings were hand-augered at this location. Oil was observed at 5.5 feet bgs within cracks and laminations in the surrounding soil but was not in the soil matrix. These observations are consistent with the conceptual site model that was presented in the *Final Feasibility Study/Removal Action Work Plan for IR21 and the Buildings 386/388/390 Area, Investigation Area C2, Lennar Mare Island, Vallejo, California* (CH2M HILL 2009g). Site conditions suggest the TPH found in this soil sample was not released from the storm sewer pipeline. The TPH-motor-oil concentration (5,200Y [Y=fuel pattern (TPH only)] mg/kg) in the soil sample collected from downgradient boring B382GB002 exceeds the Tier 2 screening level. Soil sample locations B382GB0100 and B382GB002 will be addressed by the TPH Notification that will be included as part of the

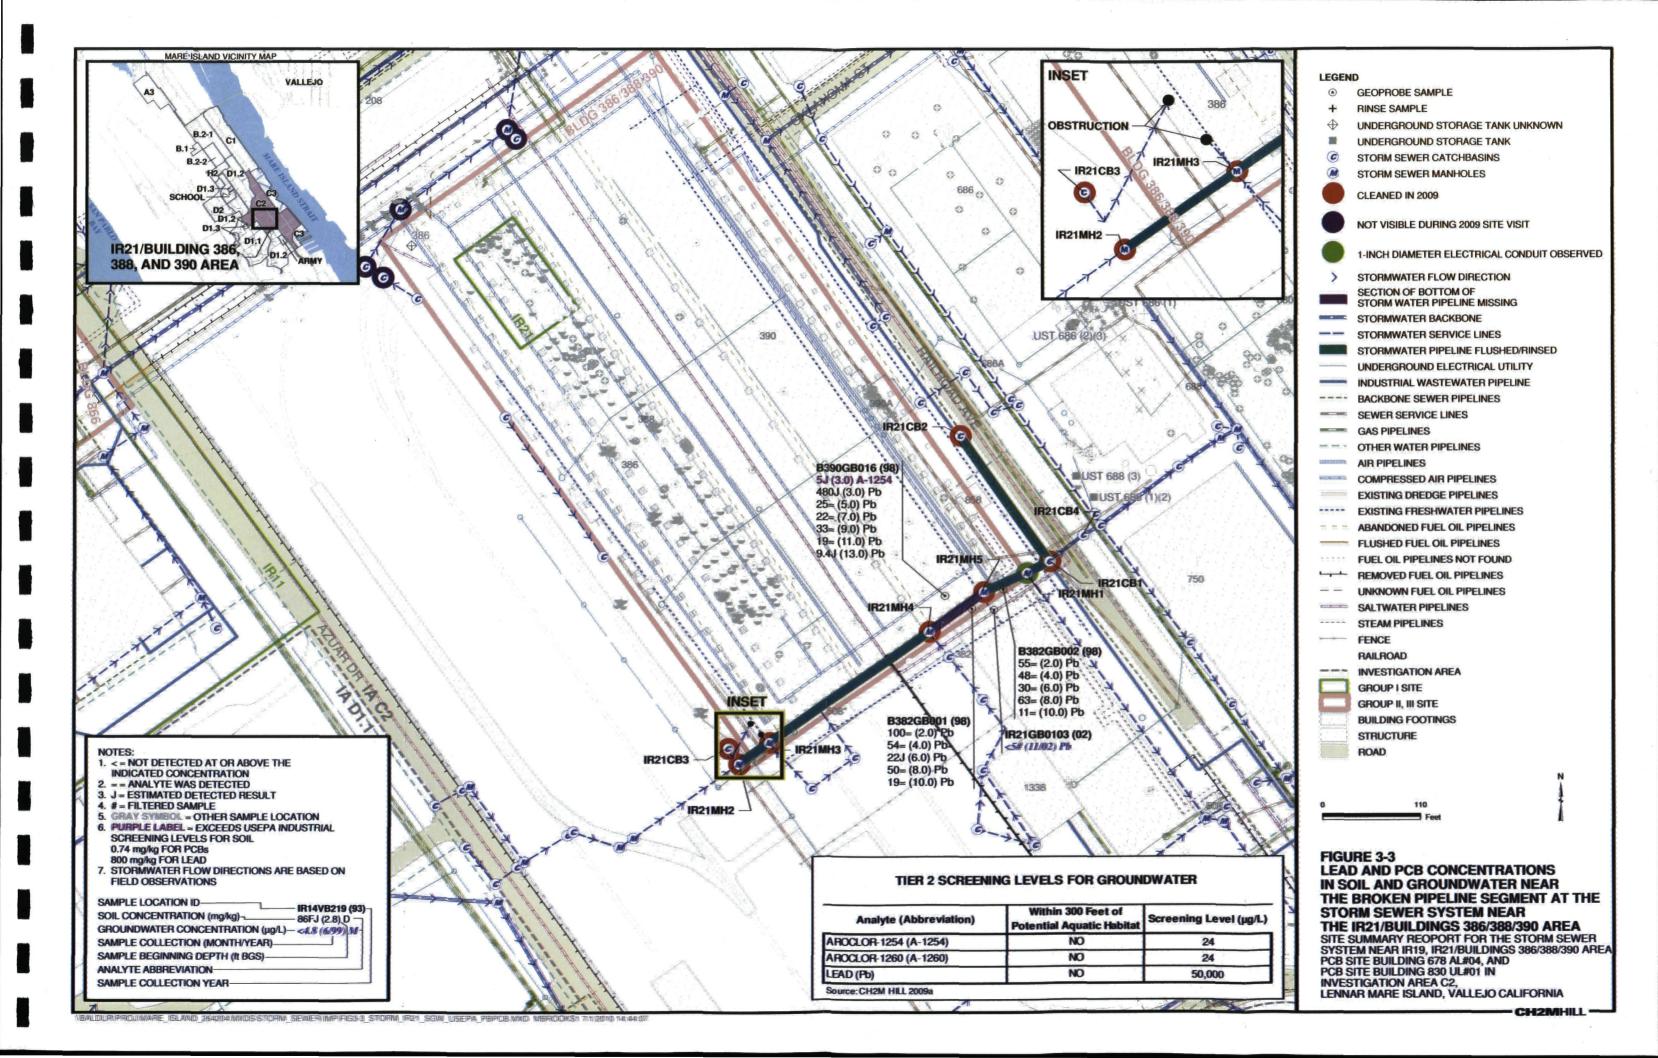
As shown in Figure 3-3, concentrations of Aroclor-1254 (5J mg/kg) in a soil sample collected from sample location B390GB007 at 3 feet bgs exceeds the USEPA industrial RSL of 0.74 mg/kg (USEPA 2009b). Concentrations of lead in soil and groundwater and PCBs in groundwater in the remaining samples did not exceed screening levels. Because the soil sample B390GB016 is located approximately 25 feet north of the storm sewer pipeline, it does appear that PCBs in this sample location are not related to a release from the broken storm sewer pipeline segment between MH4 to MH5, if any. Based on the results described above, no further action is proposed for soil and groundwater at the storm sewer system near the IR21/Buildings 386/388/390 Area. A TPH notification will be included in the IA C2 Commercial/Industrial LUC, which will identify soil sample locations where concentrations of TPH-related constituents have been detected at concentrations above the odor/nuisance screening levels.
